WATERTOWN ARSENAL
LABORATORY

MEMORANDUM REPORT

Metallurgical Examination of Defective and Satisfactory

Helmets and Helmet Steel Stock Furnished by the

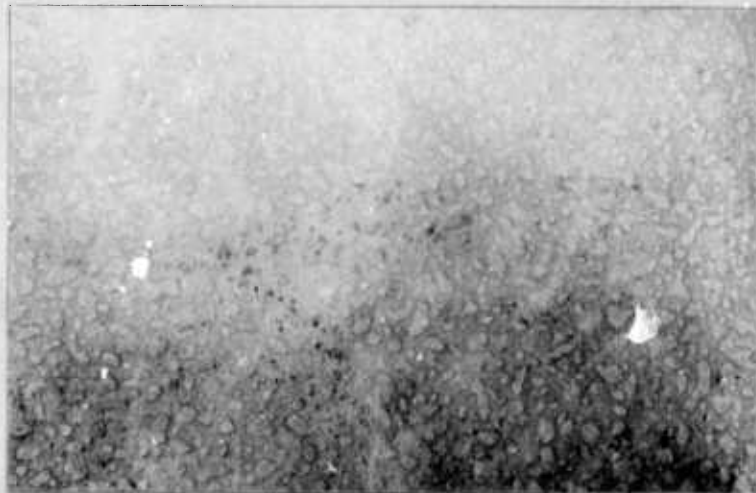
The mottled appearance, Figure 1B, has also been observed on numerous helmets supplied by both the Schlueter Manufacturing Company and the McCord Radiator and Manufacturing Company which broke during the drawing operation because of surface decarburization. There have been instances where decarburized discs did not exhibit a mottled surface but had smooth surfaces. The surface appearance is not, therefore, an entirely satisfactory gauge of the presence of surface decarburization, although discs having a mottled appearance should be considered suspect.

Steel CB. McCord Lot 575. Carnegie Heat 246803.
Decarburized steel. Magnetic traverse - 11.0".
Mottled surface condition observed on numerous
decarburized discs.

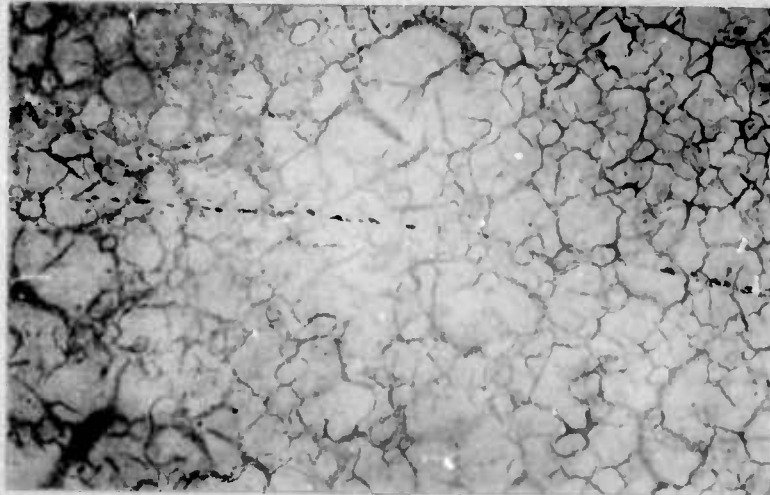
Disc A3. McCord Lot 596-0. Carnegie Heat 255799.
"Onion-skin" surface. Magnetic traverse - 4.5".
No decarburization. Surface condition probably
caused by etching during pickling.

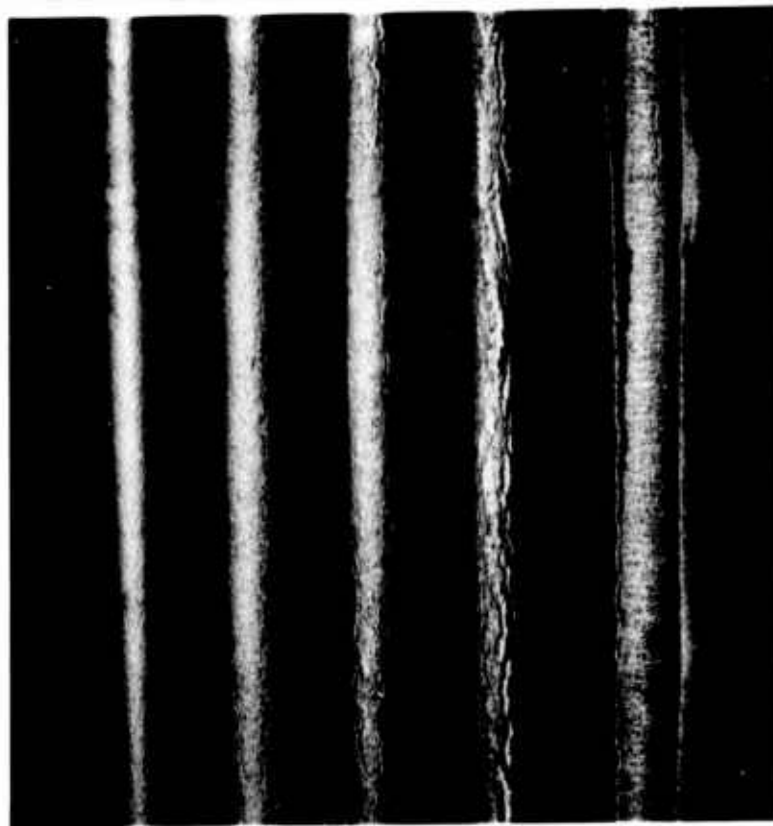
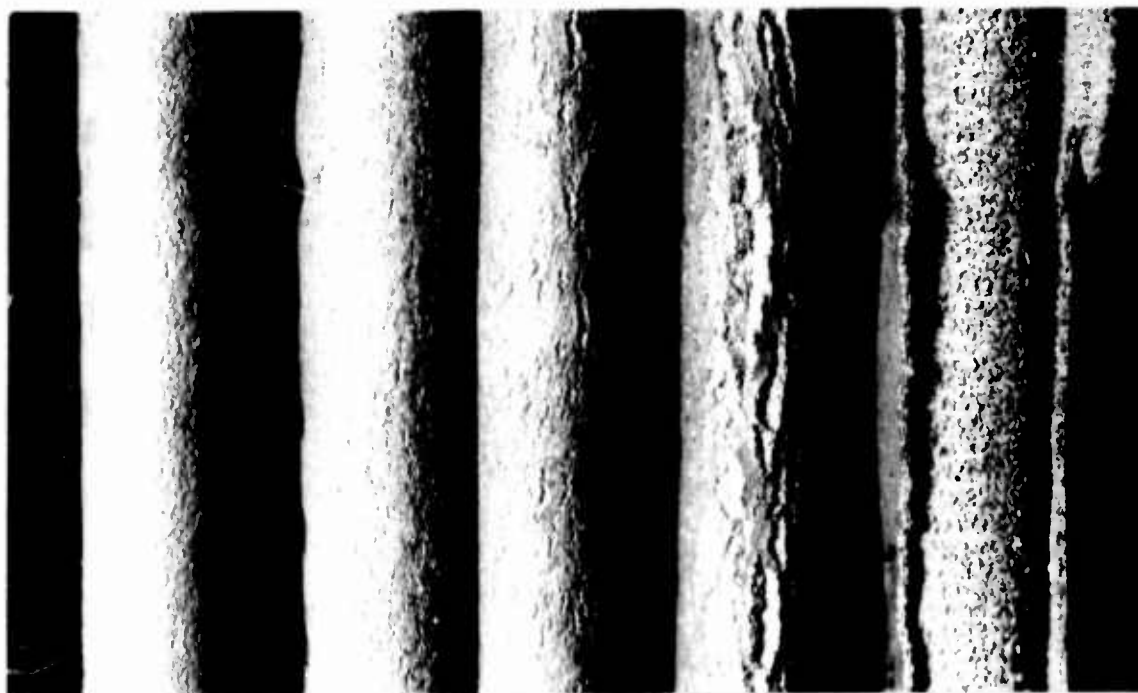
Steel 4 showed only tiny cracks on the surfaces of both bends, and according to a strict interpretation of the wording of the specification probably represents a borderline rejectable condition. A magnetic traverse of 10 inches also represents a borderline rejectable condition. A close correlation is indicated between the bend and the magnetic tests. Steel from this lot (Sharon heat no. 72202) had produced helmets which failed the ballistic acceptance test because of the presence of martensitic surface layers resulting from decarburization.

Steel CB is of considerable interest. Metallographic examination had revealed the presence of decarburization on only one surface. The bend with the decarburized surface on the outside produced the cracks shown in Figure 2. The bend with the undecarburized surface on the outside produced an uncracked appearance similar to that obtained with steel K1. This experience emphasizes the necessity for conducting the bend test in both directions so that both surfaces of the steel will be equally subjected to the tensile stresses occasioned by the bending.

Steel SB cracked severely in both directions upon being bent. This steel showed a magnetic traverse of 19" and was decarburized on both surfaces, with 0.0017" thick layers of martensite being developed on the surfaces.

Steel C1 split open upon being bent. Metallographic examination revealed the presence of a lamination of martensite below the surface of the steel. This lamination probably originated in an ingot defect that was rolled out in the sheets.* This steel had a magnetic traverse of 37".

Steel: Schluter 62A | Schluter 63A | McCord 575 | McCord 587 | Schluter 37B
 Sharon 72195 | Sharon 72202 | Carnegie 246803 | Sharon 72403 | Sharon 72044

Magnetic Traverse: 2.5" 10.0" 11.0" 19.0" 37.0"

Defect: None Decarburized Decarburized Decarburized Lamination of martensite

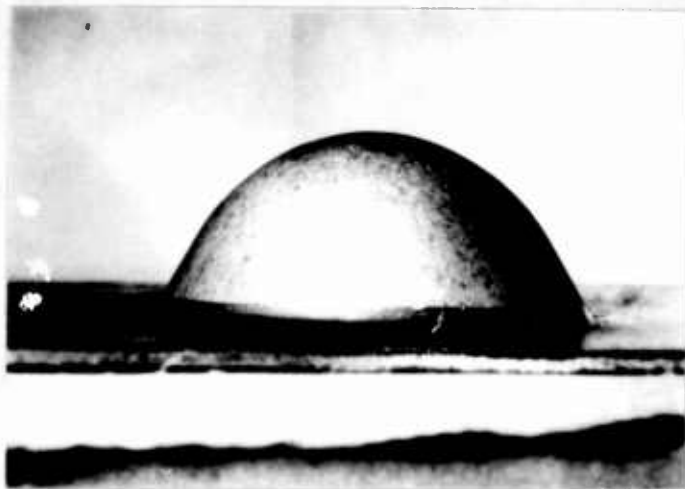
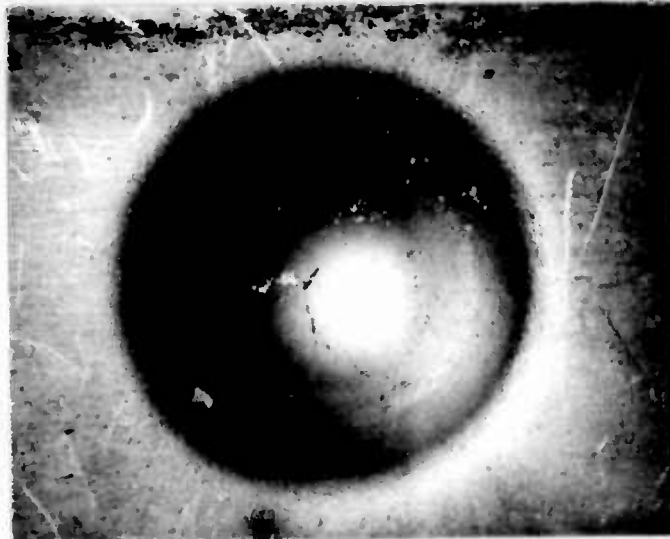
-A-

A steel free from metallurgical defects presents very smooth surfaces on the outside and inside of the Olsen cup, see Figures 3A and B. When a decarburized steel is subjected to the cupping test, a network of fine cracks similar to those formed in the bend test appears on both the outside and inside surfaces of the cup giving it a rough appearance, see Figures 3C and D. Figure 3D also shows the characteristic mottled surface appearance frequently associated with decarburization. Steel containing martensite laminations below the surface fracture in a very characteristic manner, see Figures 3E and F.

Steel E - Schluster Lot 62A, Sharon Heat 72195. Satisfactory steel. Appearance of cup prior to fracture. Surface of steel is smooth and free from cracks. Magnetic traverse - 2.5".

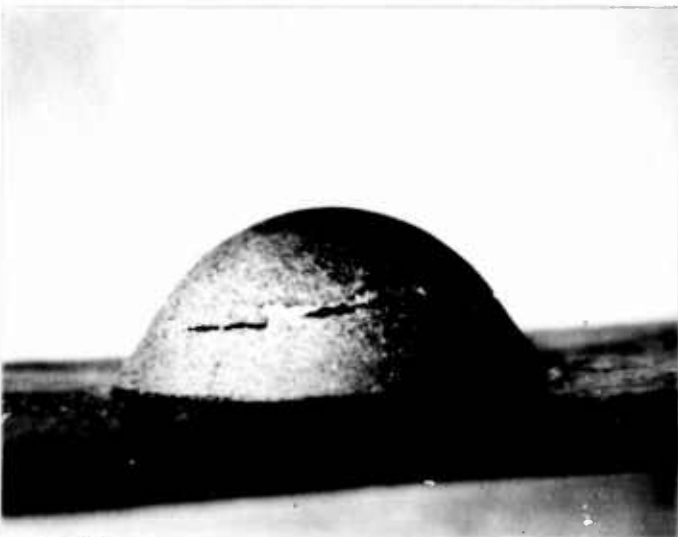
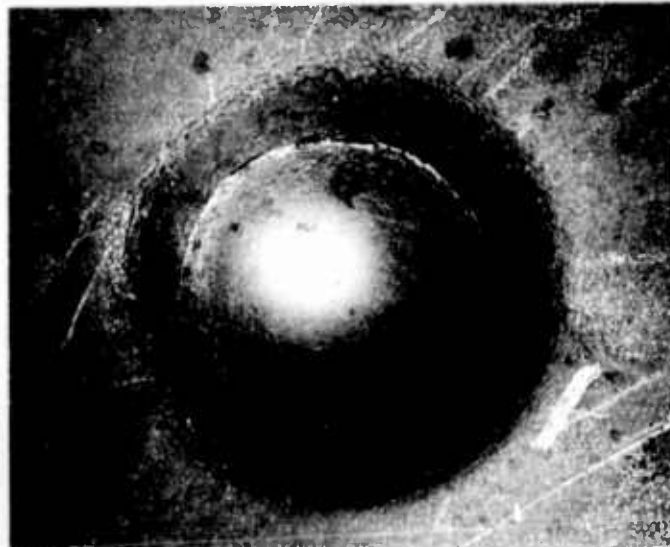
-C-

Steel A - Schluster Lot 48A, Sharon Heat 72312. Decarburized steel. Appearance of cup after fracture. Surface cracking and jagged fracture typical of decarburized steel. Magnetic traverse - 15.0".

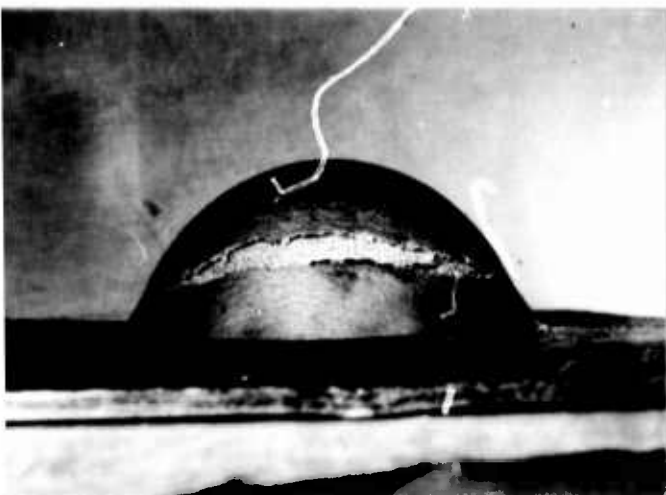
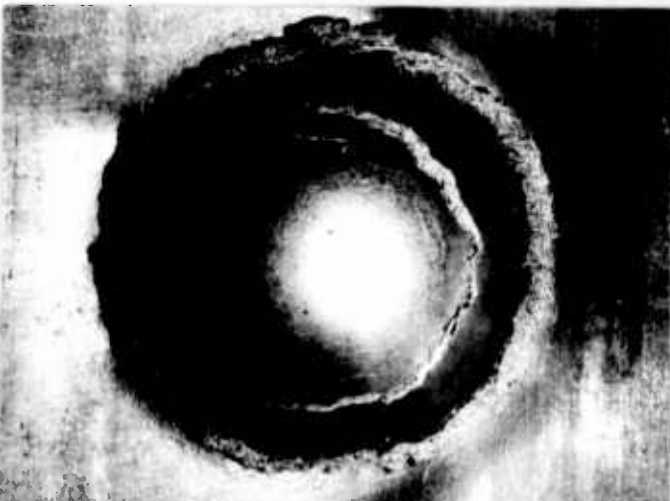
-E-

Steel C1 - Schluster Lot 37B, Sharon Heat 72044. Laminated steel. Appearance of cup after fracture. Cracking and separation of steel along lamination. Magnetic traverse - 17.0".

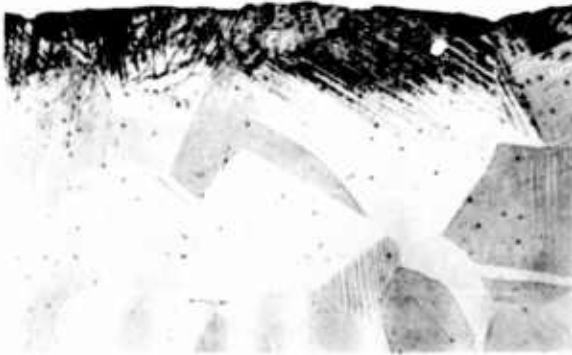
-A-

The cracked helmets examined in this investigation present two distinct metallurgical defects—surface decarburization, and undissolved grain boundary carbides. Of the helmets examined, M1 and D4 were badly decarburized, Figures 4A and B, and helmets D6, E1, E2, F5, F6, and F8 contained varying amounts of undissolved grain boundary carbides, Figures 4C and D. Small cracks which frequently occur in the martensitic layer of cold-worked decarburized helmet steel are shown in Figure 4B. The carbide grain boundary networks are believed to be the result of either too low an austenitizing temperature or too short a time at temperature, resulting in incomplete solution of the carbide in austenite. Exactly similar microstructures have been produced at this arsenal by quenching helmet stock from 1475°F.*

Helmet D4, McCord Lot 544B, Carnegie Heat 255739. Martensitic surface layer resulting from decarburization. Width of layer - 0.0016". Magnetic Traverse - 23.0".

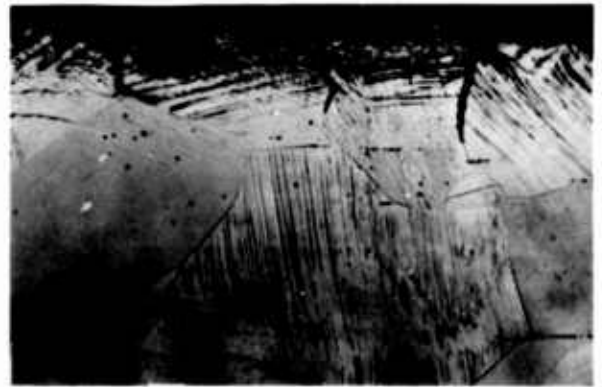
-B-

Helmet D4. Typical cracks in martensite layer resulting from deformation of brittle constituent.

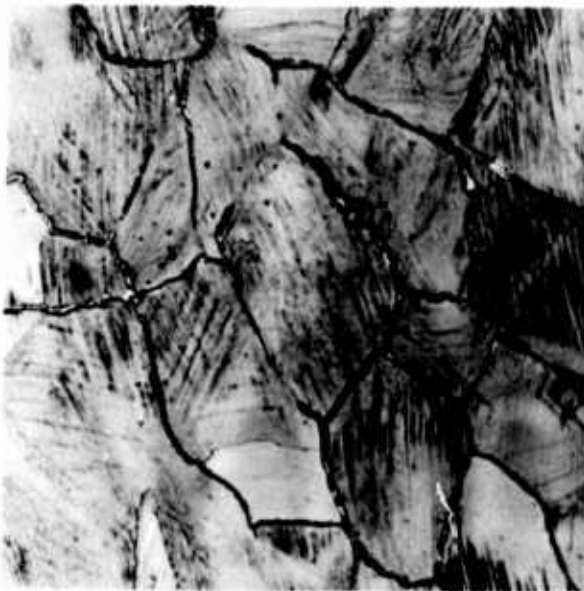
-C-

Helmet E1, McCord Lot 541C, Sharon Heat 72203. Network of undissolved carbides at grain boundaries. Magnetic Traverse - 3.0".

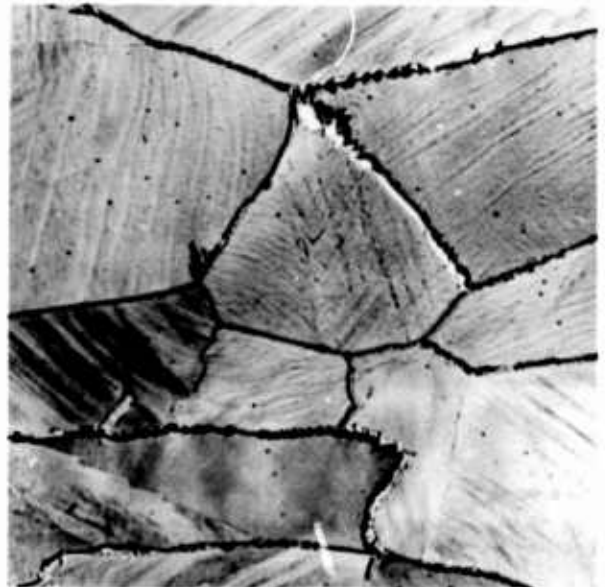
-D-

Helmet E2, McCord Lot 549B, Sharon Heat 72198. Undissolved carbides. Magnetic Traverse - 1.0".

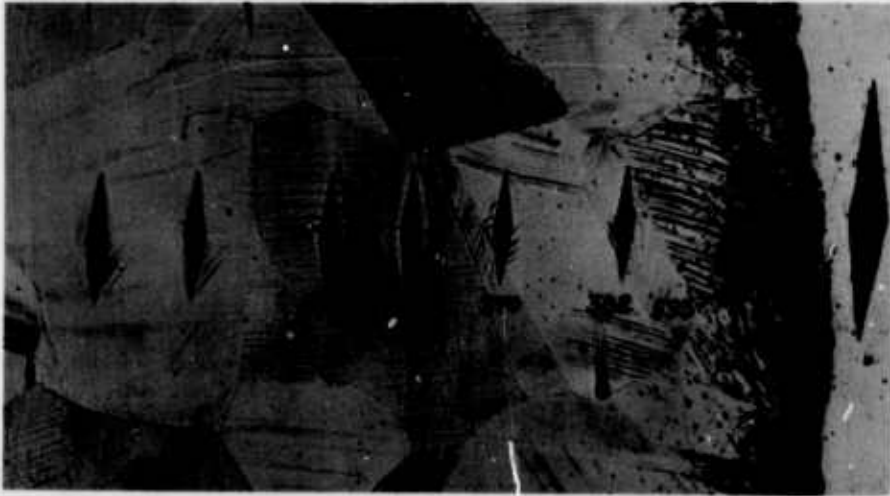
To confirm that the microconstituent occurring at the surfaces of decarburized helmet stock is martensite, Knoop hardness surveys were made on numerous cross-sections of decarburized material. Figures 5A and B are photomicrographs of Knoop hardness traverses across a section cut from helmet D4 which broke during the forming operation. The hardness

of the decarburized layer is 593 Knoop, while that of the cold worked base metal is 359-370 Knoop. The Knoop hardness numbers in this range are roughly equal to the Vickers Pyramid hardness numbers. Hardness surveys made on samples of decarburized helmet stock in the annealed condition show hardnesses of 336-395 Knoop in the decarburized layer and an average of 222 Knoop in the base metal. The decarburized surface layer probably consists of a mixture of austenite and martensite, the amount of martensite, and consequently the hardness, being a function of the extent of decarburization.

Helmet D4, McCord Lot 544B, Carnegie Heat 255739. Knoop Hardness Survey - 100 gram load.

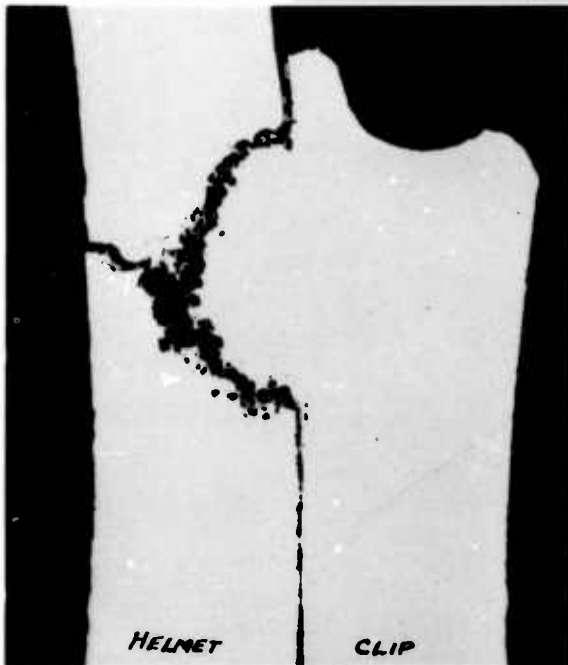
The eight spot welds on helmets 01 and 04 were prepared for microscopic examination. Without exception, all of the welds examined exhibited severe fusion zone cracking. Photomicrographs shown in Figures 6A, B, and C illustrate the extremely poor welds. The cracking was entirely confined to the austenitic steel, occurring at the boundary between the base metal and the molten pool of the weld.

Unetched -A- X25
Helmet C4, McCord Lot 549B, Sharon
Heat 72198. Severe fusion zone
cracking in the Hadfield Steel.
Very poor weld.

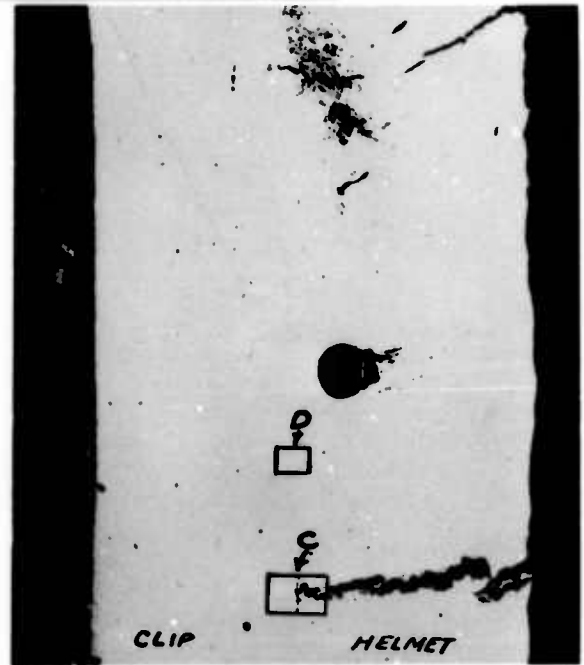
Unetched -B- X25
Helmet C1, McCord Lot 533A, Carnegie
Heat 186917. Weld porosity and
fusion zone cracking.
Unsatisfactory spot weld.

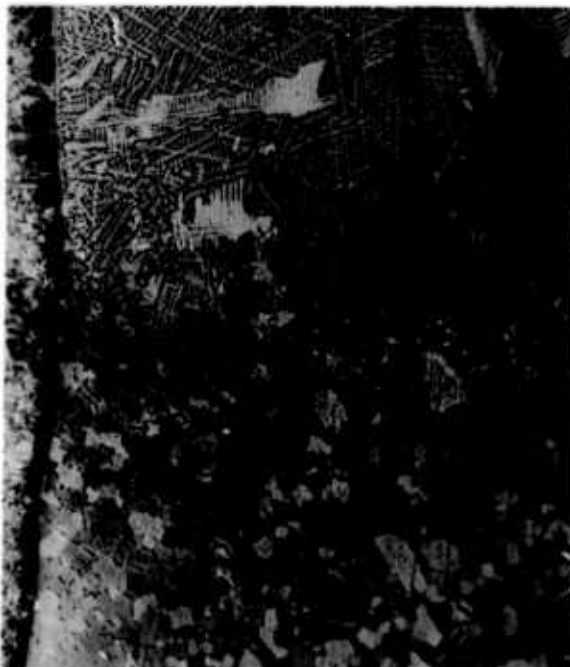
Nital -C- X100
Helmet C1. Area shown in -B-.
Severe cracking at boundary of base
metal and zone molten during spot
welding. Dendritic structure in
molten region.

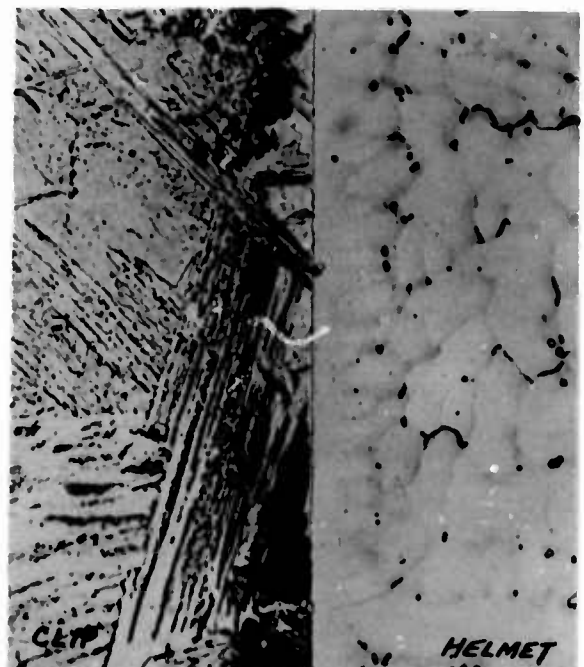
Nital -D- X1000
Helmet C1. Ferrite, pearlite, and
martensite in magnetic steel clip.
Cast structure showing coring in
austenitic steel.
